Testing building envelope systems using infrared thermography

John Snell
Rob Spring, P.E.
Snell Infrared
PO Box 6
Montpelier, VT 05601-0006
800-636-9820
www.snellinfrared.com

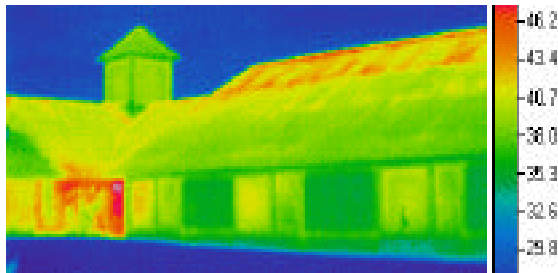
Image 1. Excessive heat loss and poor ventilation resulted in costly ice damage to this large roof.

Often the problems—as well as their causes and consequences—simply cannot be seen until after costly damage has been done. At that point the only recourse may be extensive, costly reconstruction. The commercial building in Image 1, a nursing home, had extensive problems resulting from a poorly designed roof/ceiling insulation system; these included excessive heat loss during the winter months and, as a result, extensive ice damage due to snow melt. Hundreds of thousand so dollars were spend in various, poorly planned attempts to correct the underlying causes. In the end the owners simply lived with the continued problem because corrective actions were deemed too expensive. Despite this unfortunate resolution, the thermograms helped the owners negotiate a financial settlement with the architects and contractors.

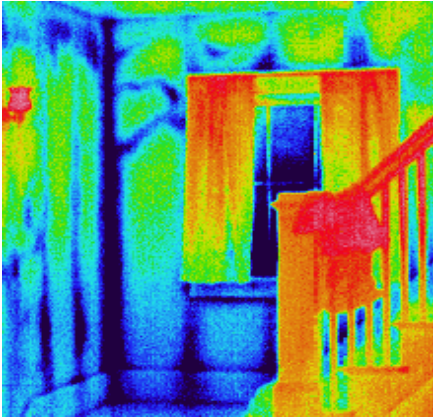
Image 2. When conditions are right, it is possible to locate missing or damaged insulation, such as this poorly installed injected foam in a residential building.

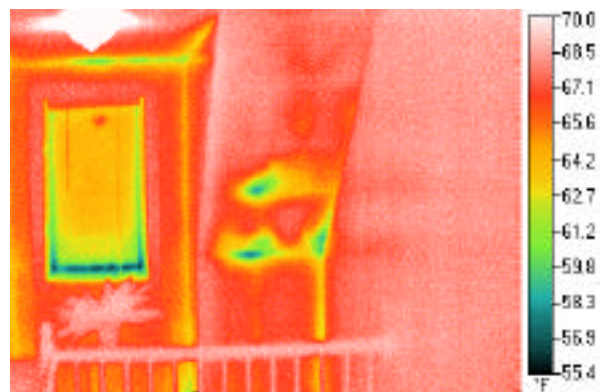
Image 3. The improperly installed fiberglass yields an irregular thermal pattern. The resulting cold spots commonly host wall stains or mold growth.

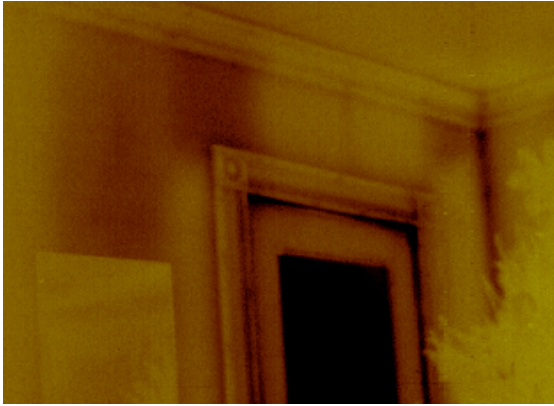
Image 4. Properly installed cellulose is an excellent insulation. Unfortunately it is often poorly installed with missed areas and settling the most common quality problems.

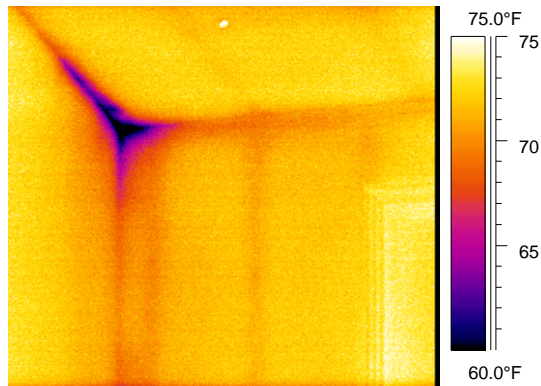
Image 5. Many types of insulation are susceptible to air infiltration. The fiberglass shown here does not stop air flow through the wall section.

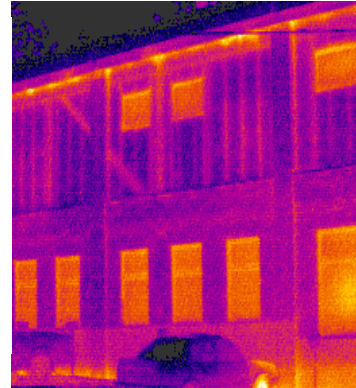
Image 6. All the framing and insulation is clearly visible in this commercial building. Normal pressure differences on the top floor result in air leaking past the envelope through various pathways.

Most types of insulation are not effective at reducing air movement through the thermal perimeter. Good construction practice includes interior air sealing; if this is not in place effectively, air can move through the interior and exterior surfaces and through the insulation. Unfortunately, fiberglass is particularly susceptible to this problem. Thus, while the insulation may be present, it does not perform as expected when the building is under a pressure gradient. Image 6 shows the impact of warm air leaking out of this commercial building. This will typically go unnoticed until the fuel bill is paid.

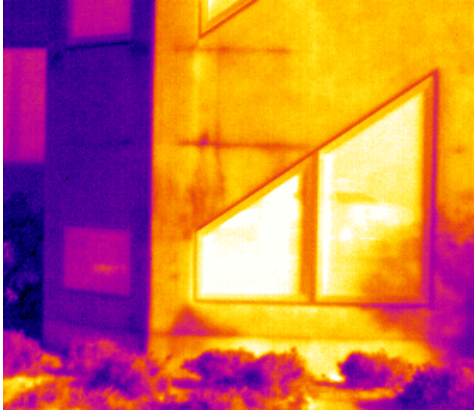
Image 7. EIFS construction is particularly susceptible to water intrusion resulting in both mold growth and wood rot problems.

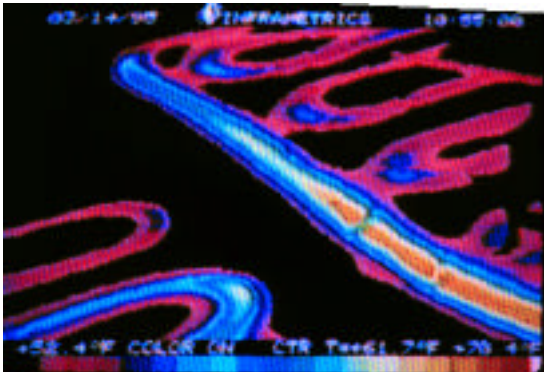
Image 8. Hydronic heating coils embedded in a concrete floor show up clearly in this thermal image.

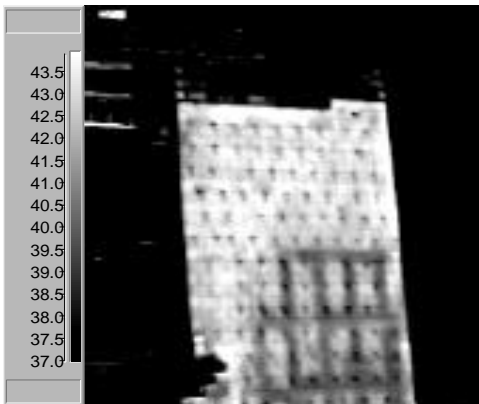
Image 9. This block wall is not uniformly grouted as was specified, leading to severe structural problems
 —image courtesy Phil McMullen

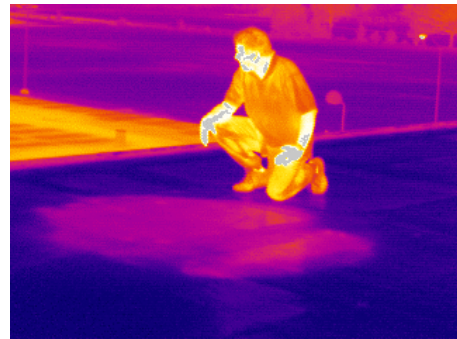
Image 10. The wet insulation in the roof system shows up clearly due to its greater thermal capacitance.

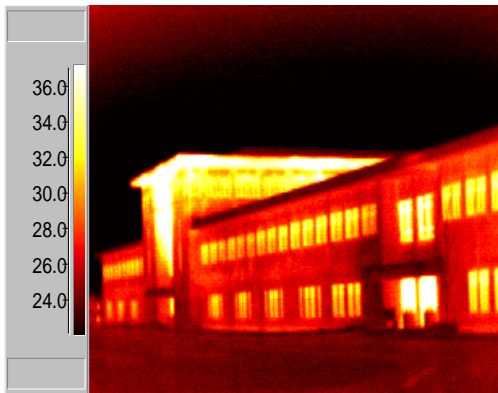
Image 11. During the commissioning of this building thermography revealed an extreme problem involving exfiltration through the soffit. Courtesy Phil McMullen
